Volunteer Chief and Fire Fighter Die After Being Ejected During a Rollover Crash—Virginia

Death in the Line of Duty...A summary of a NIOSH fire fighter fatality investigation

F2010-19 Date Released: February 28, 2011

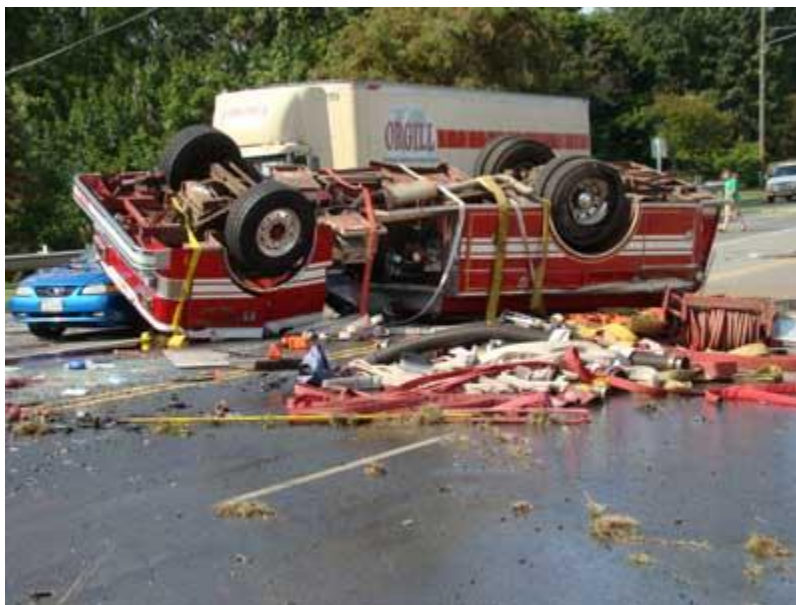
Crash photo.
(Courtesy of the Franklin News Post.)

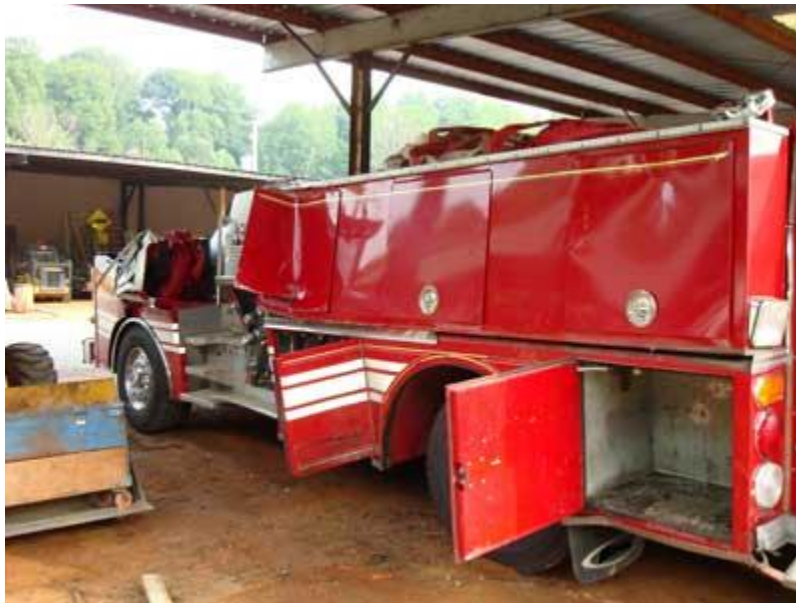
The engine involved in this incident was a 1988, 1,250-gpm custom engine with a 1,000-gallon water tank ([see Photo 1 and Photo 2](#)). The fire department purchased this pumper as a used vehicle from another department approximately 10 years prior to the incident. The gross vehicle weight rating of the engine was 37,180 lbs. The engine had an automatic transmission, diesel engine, air-actuated drum brakes with no auxiliary braking devices, and two axles with six wheels (two in the front and four in the rear). The engine had an electronic siren, air horns, and emergency lights. The engine had seat belts for the driver and passenger. The water tank was inspected at the town's storage facility and appeared intact, although the configuration of the tank baffles could not be verified at the time of the inspection. The two victims were the only personnel on board the engine at the time of the crash.

Photo 1. Side view of the apparatus, post incident at the storage facility.

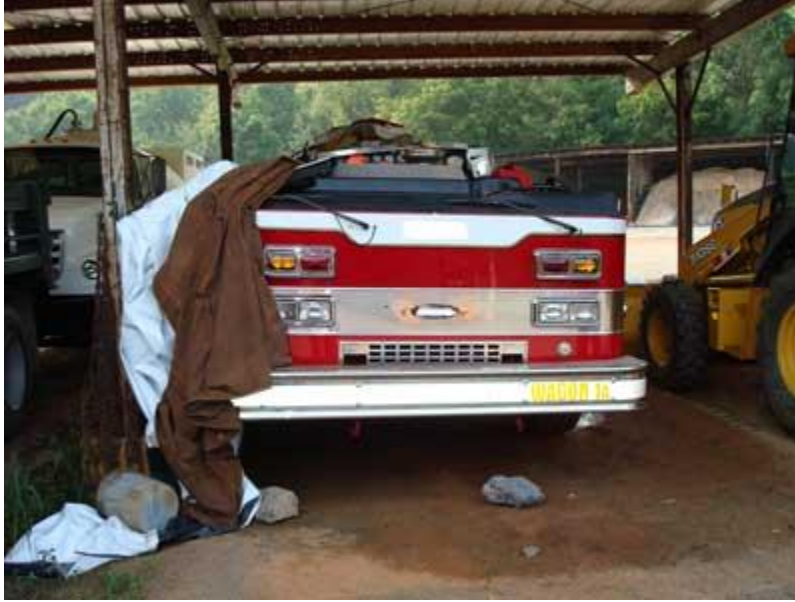
Photo 2. Front view of apparatus post incident with top of cab sheared off by crash impact. (NIOSH photo.)

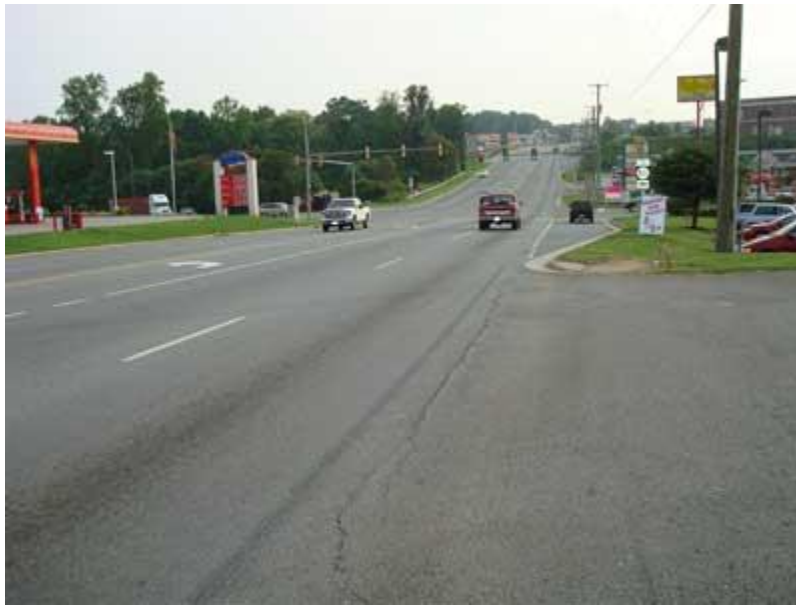
A county fire marshal was responding with lights and siren to the same mutual aid structure fire, traveling east on the same road just ahead of the victims' engine. The fire marshal stopped at the red light and then successfully traveled through the intersection in the direction of the response ([see Photo 3](#)). Note: The fire marshal told NIOSH investigators that he was 5-10 seconds in front of the victims' engine, and he estimated that the engine would have caught the same red light as his vehicle. The fire marshal did not see the SUV strike the engine, and he was not aware of the crash until he heard a dispatch for a motor vehicle accident involving a fire truck that was dispatched at 1633 hours.

**Photo 3. Intersection where crash occurred (same direction of travel as incident apparatus, eastbound).
(NIOSH photo.)**

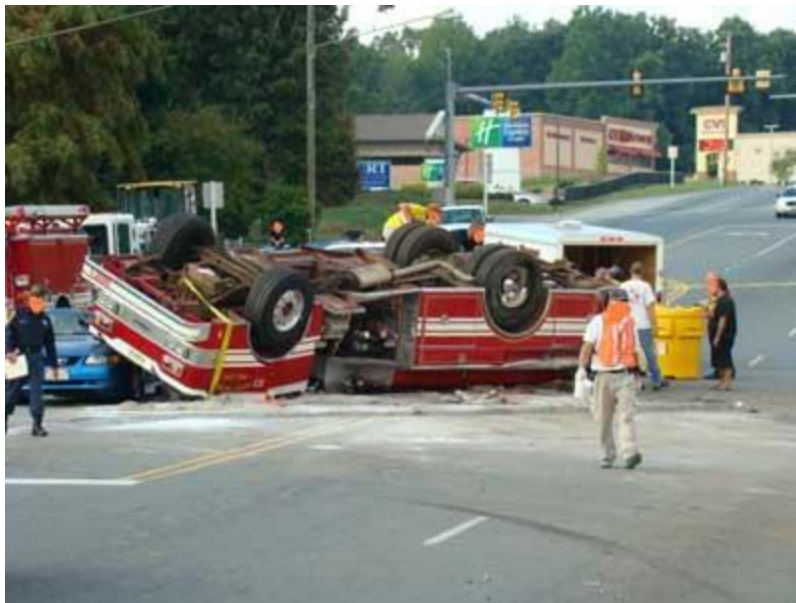
The engine had traveled approximately 1.8 miles when it encountered the red light at the intersection. The engine entered the intersection and was struck on its left rear side by an SUV that was entering from the north (left) side of the intersection. The engine struck the curb on the south (right) side and then rolled over; both victims were ejected. The engine rested on its top facing northwest and impacted a car in the opposing lane ([see Photo 4](#)).

**Photo 4. Crash scene.
(Photo courtesy of the Franklin News Post.)**
